## **Investigation of Spare Duct Banks to be Used for Cable Circuit Replacement Feeders A32T-A33T**

Final Draft Report

January 17, 2020

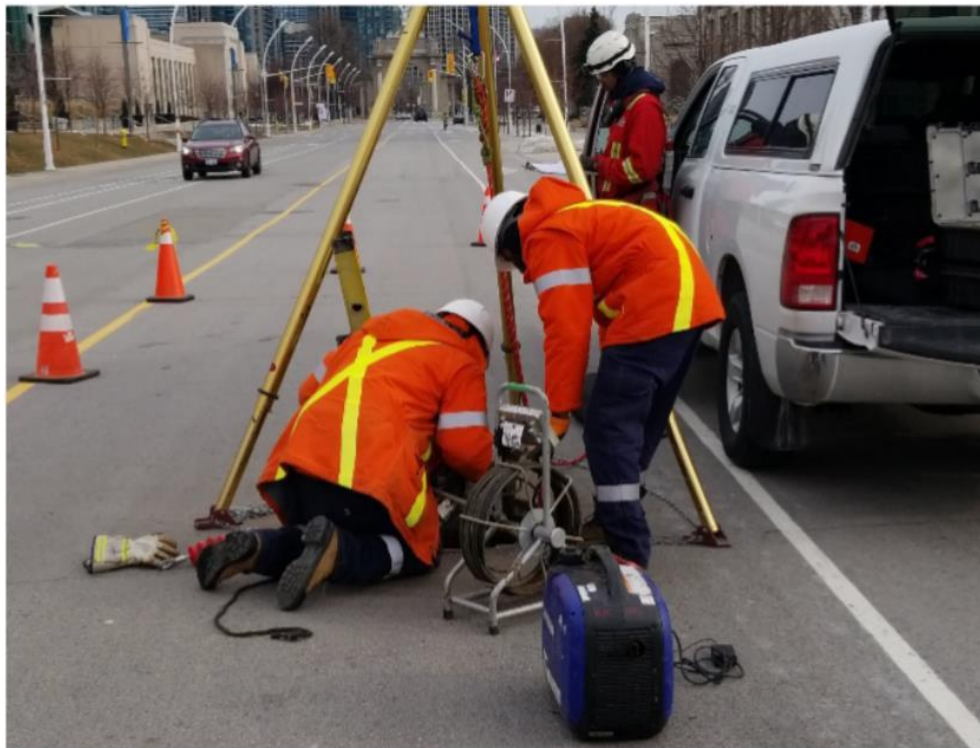
**Visual inspection being conducted using an endoscopic camera in Manhole #120**

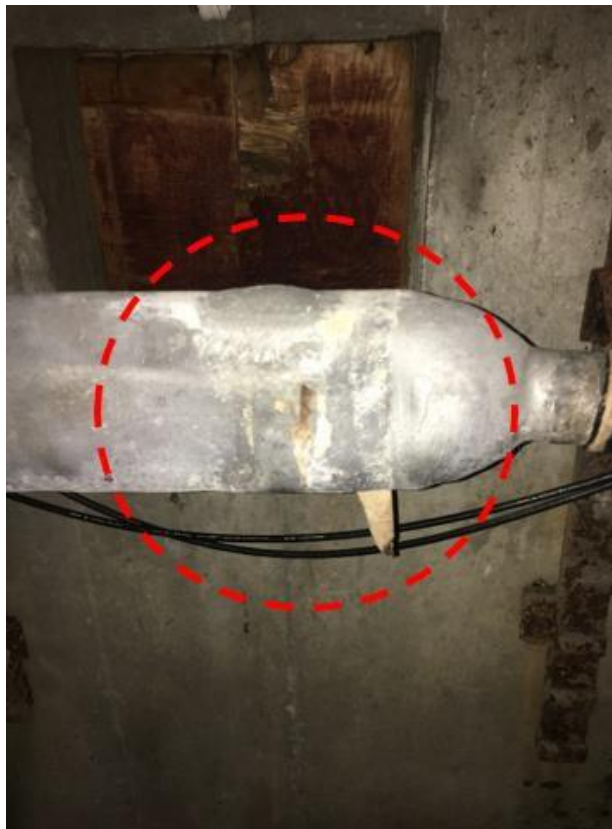
**Splice anomaly observed in Manhole #202**

- Distance to ground ~15'
- We found another splice anomaly. It had a compressed area on it as well as some bulges
- We sent the endoscopic camera through ducts 2 and 5. The camera couldn't reach the whole stretch and we found it to have a lot of dirt/contamination built up as we approached the end. Ducts will have to be blasted clean but looked good overall
- We were unable to send the mandrel through due to the splice anomaly in Manhole #19

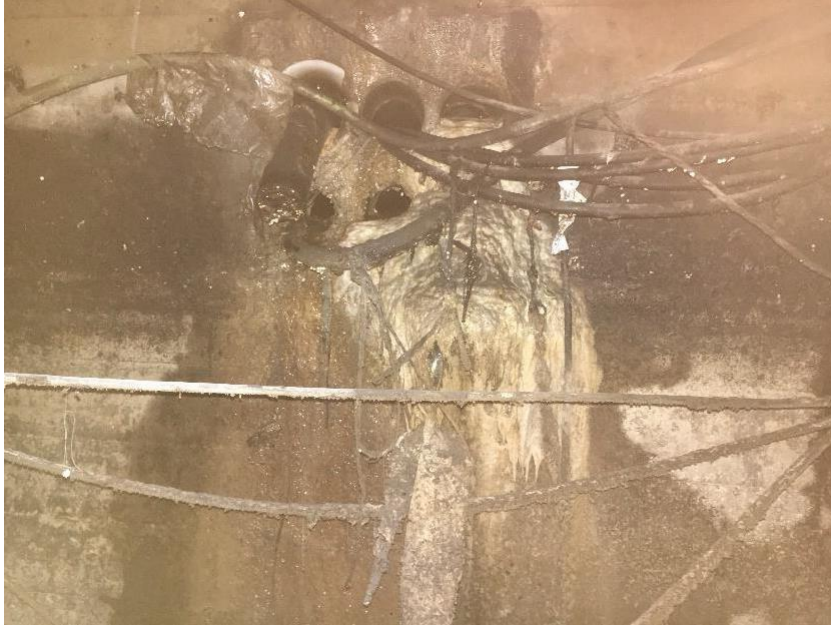
**Excessive grime observed in Manhole #130B**

- This Manhole appears to be utilized as a hub of sorts being located right at Vault TOX. There are many other ducts going multiple directions that were out of our scope
- The most confusing aspect was that the duct bank running north towards Manhole #15 had the 13.8 kV feeds in the bottom middle two ducts and the accompanying ground in the bottom east duct as expected. However, all the other ducts were empty. No way of knowing where they are going/coming from
- Sent the camera through two ducts (2 and 5) but could not make it through the whole stretch due to excessive grime. Pulled on the twine at each end to confirm continuity. Ducts will need to be blasted clean
- This manhole is particularly filthy compared to the others

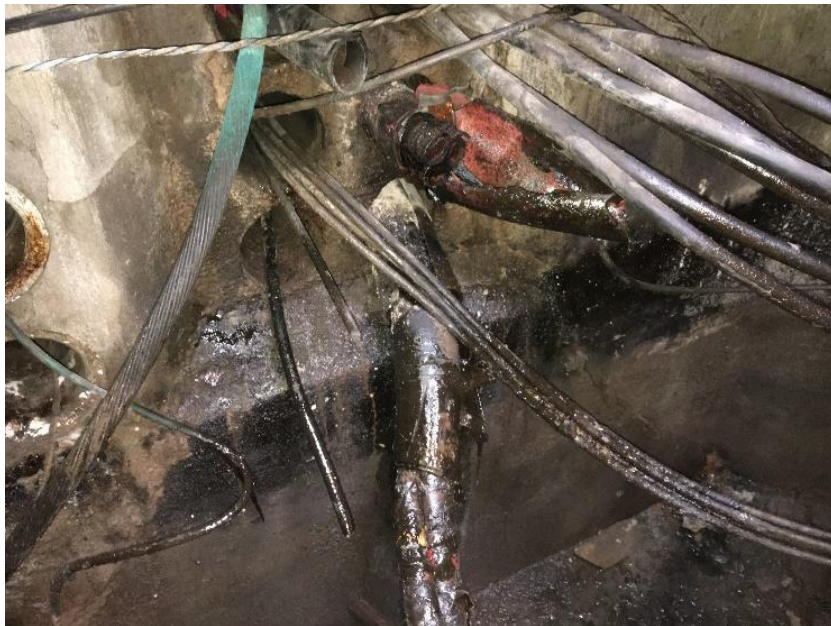
**Oily residue observed in Manhole #120**

- Distance to ground approximately 13' (Contains ~3' "chimney")
- Had to grind tacks off of manhole lid prior to opening. This will need to be rewelded in the future as required
- Some cut off 13.8 kV PILC cables contain oily residue as do some splices on other cables
- Endoscopic camera sent South to Manhole #13 through ducts 2 and 5. No anomalies noted

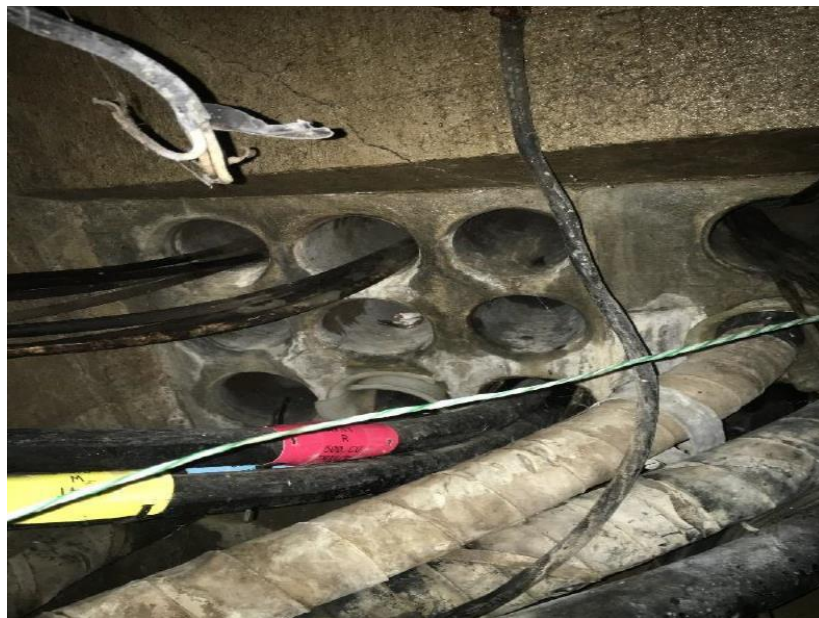
- Approximately 4" gap between 3x4 duct banks going South to Manhole #2 (5063). Need to enter Manhole #2 (5063) to know how many ducts make it there
- Unable to send the endoscopic camera through to Manhole #2 due to deformed splice found
- Duct #4 has a 13.8 kV cut off cable that can be used as a spare in the ducts going South to Manhole#2
- The manhole contains 13.8 kV and 4.16 kV cables

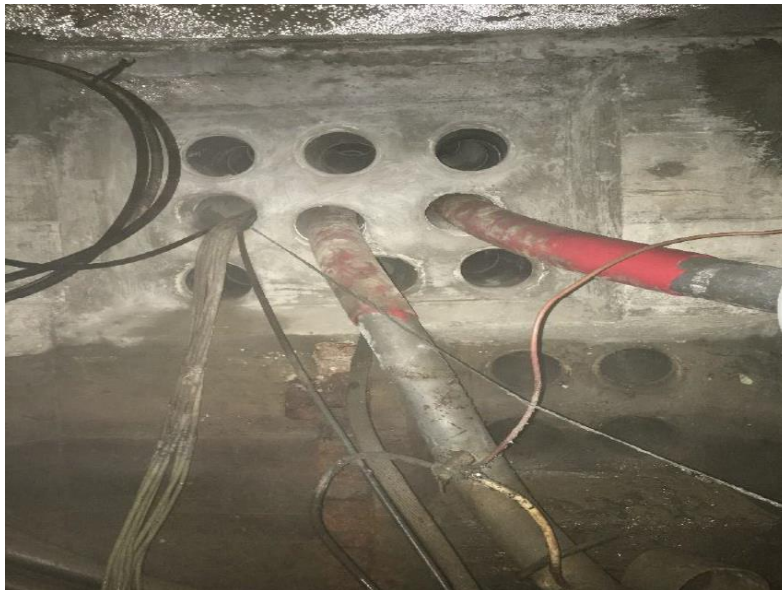
- Contains a lead splice and a Raychem splice
- Endoscopic camera sent North to Manhole #2 in ducts 2, 3, 4, and 6. Excessive dirt and corrosion prevented the camera from reaching beyond ~150'. Ducts looked good otherwise and appear to just need cleaning
- Endoscopic camera and mandrel sent South to Manhole #4 in ducts 1 and 4. Ropes left in ducts.

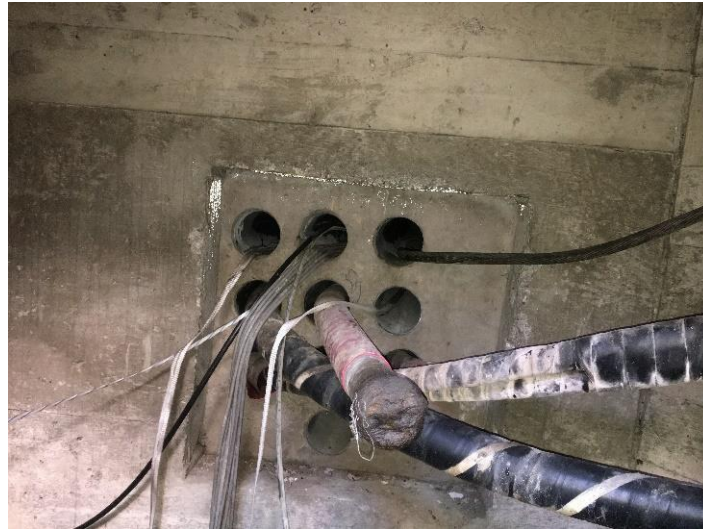
- Duct #7 was found to be visually clear
- Duct #5 had a 13.8 kV cut off cable that can be used as a spare
- Distance to ground ~10' similar to manhole #4

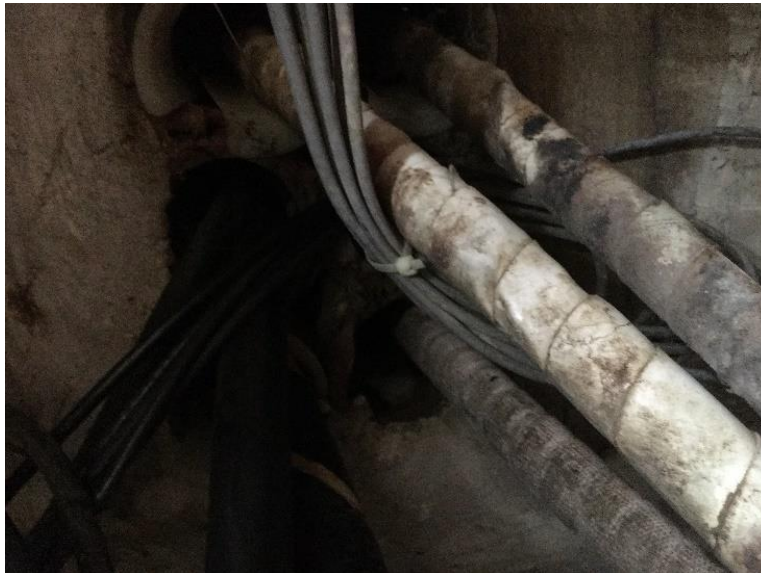
- Distance to ground ~10'
- 13.8 kV cable wrapped in suspected ACM (sample was taken, but asbestos was not detected through lab testing)

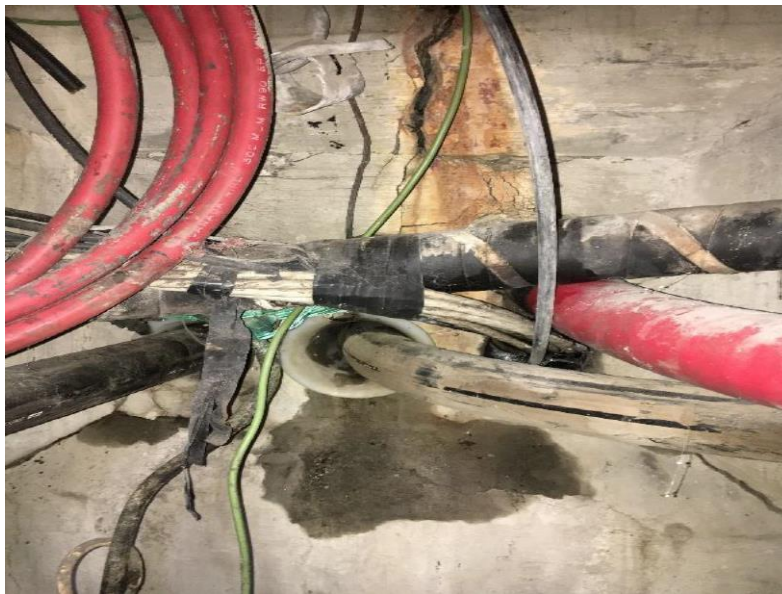
- Distance to ground ~10'
- 13.8 kV cable wrapped in suspected ACM (sample was taken; but asbestos was not detected through lab testing)
- No ducts available going west to Manhole #9, however, the 13.8 kV cable in duct 5 has been cut off
- Manhole #7 also contains an offshoot from the main 13.8 kV run that goes south to Manhole #8.

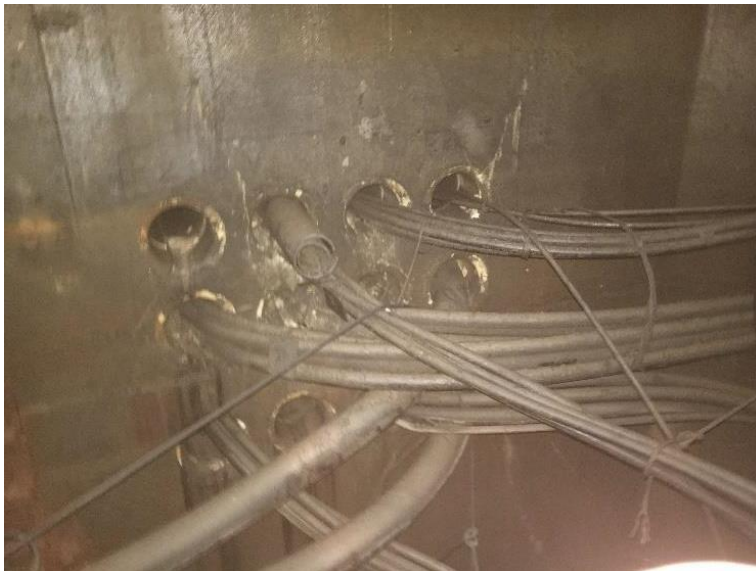
- Distance to ground approximately 14' (Contains ~4' "chimney")
- Found a deformed 13.8 kV PILC splice just off of the floor

- Endoscopic camera sent through ducts 1 and 6. It could not reach the entire stretch but it went through very easily with no noted anomalies. Ducts both found roped.
- Entry into the manhole was very difficult due to an abundance of LV cables coiled around the chimney

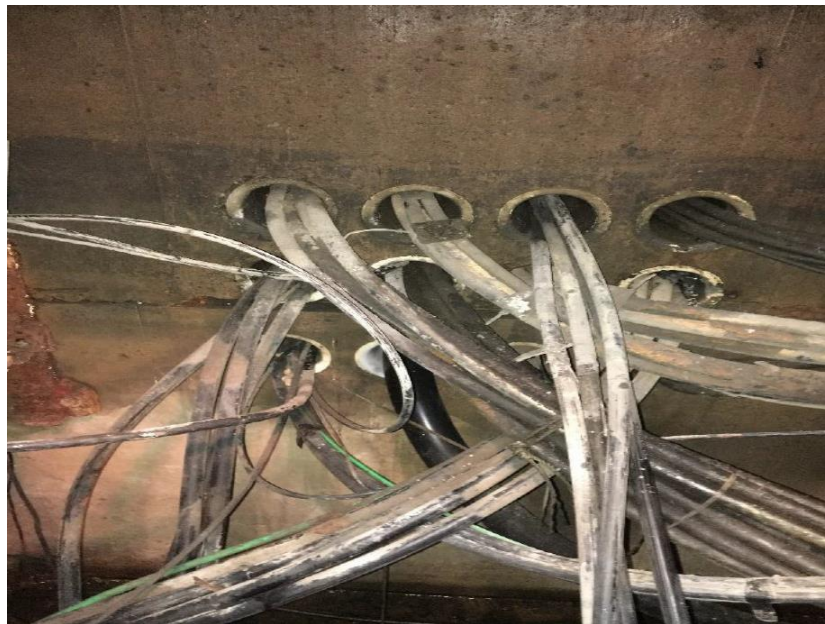
- Distance to ground ~15'
- Found deformed 13.8 kV PILC cable splice. Splice was compressed and the technician could feel the heat coming off of it
- Infrared camera was unable to detect any heat but it may have been an emissivity issue. Heat could also be emitting from the bottom of the splice, undetectable at the top where it was scanned
- Entry was difficult due to an abundance of LV cables at the top of the manhole

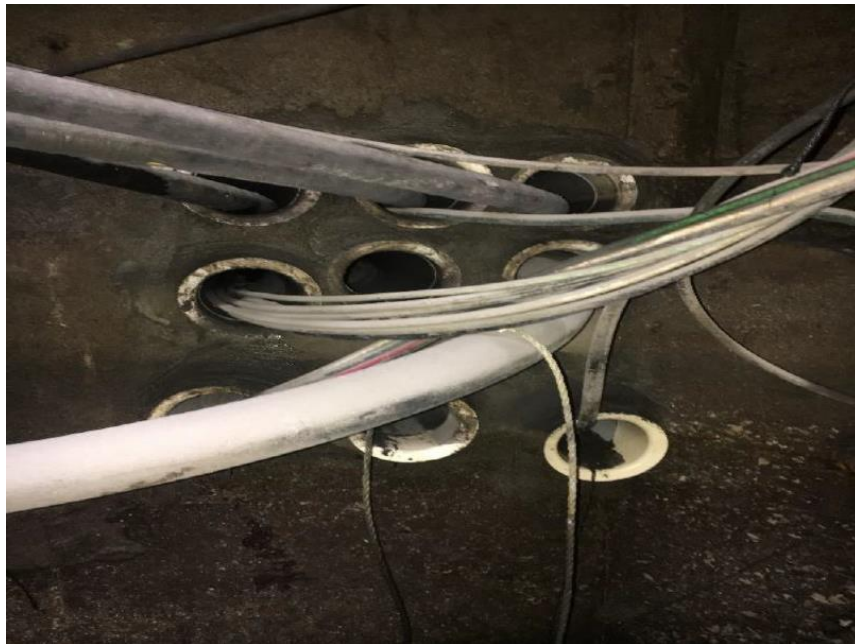
- Distance to ground approximately 12'
- Compressed splice found on 13.8 kV cable in duct 8. It didn't look as bad as some of the others so the technician was comfortable working near it for a short time
- Endoscopic camera and mandrel sent West to Manhole #18 in ducts 5 and 6
- Rope left in ducts after sending through the mandrel
