Subject: **Garden of the Greek Gods & Other Collections - Additional Information**

Site Visit Report – 3 July 2014

Title: The Garden of the Greek Gods

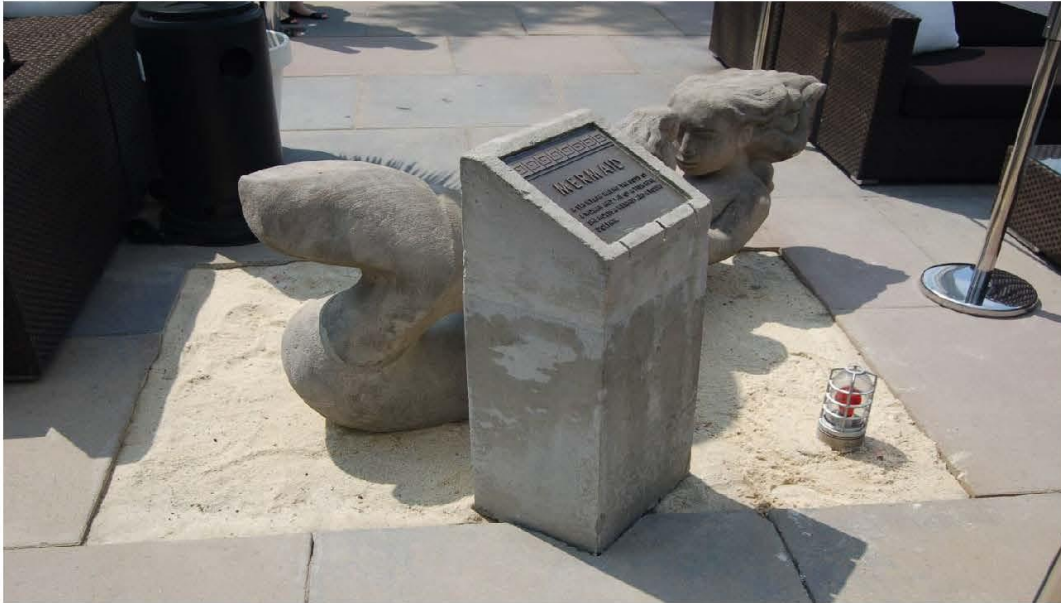
- For example, the location of **Mermaid** poses a potential trip hazard, by blocking a passage way. It is low to the ground and has a number of projecting points. Fire and safety inspections should be conducted to ensure no liability issues have been created. See images 3 and 4.

Image 4: Mermaid, possible trip hazard.

- Retain a stone conservator to provide a pricing for repair of damaged sculptures, especially **Cyclops, Sea Horse, and Hercules**.
- Relocation of **Mermaid** and **Narcissus** or modification of surrounding furniture placement to increase spacing between sculptures and walk ways around sculptures and thus reduce trip hazards.
- Remove excess wood chips from around bases.
- Fire and safety inspections should be conducted to ensure no liability issues have been created.
- Ongoing monitoring and condition assessment of sculptures.

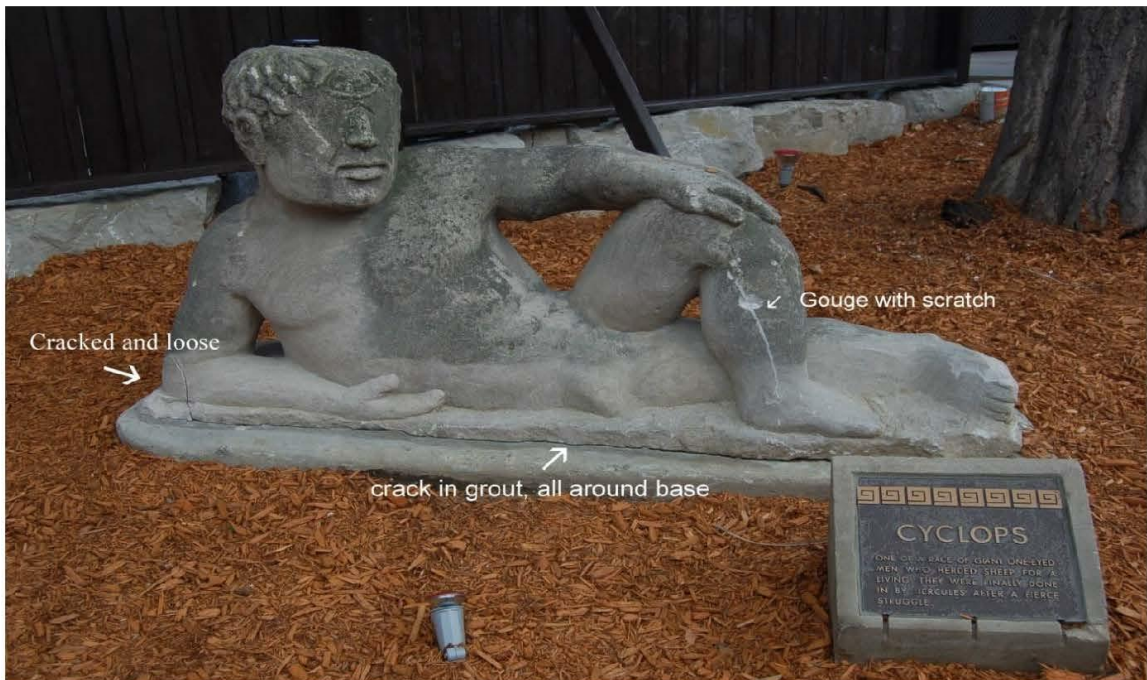
Image 5: Cyclops

13	Cyclops	<ul style="list-style-type: none"> Damage to proper left leg, combination of long scratch with gouge/loss of stone Minor scrapes and small gouges on proper right shoulder and face/hair Sculpture may be separated from base. Crack in grout is visible around entire base; sculpture most likely secured to base by rebar rods. Rebar provides actual anchorage while the grout prevents water penetration and potential corrosion of rebar. Proper right elbow is cracked and can be easily moved – danger of detachment, if left unrepaired. Wood chips too high around base. 	<ul style="list-style-type: none"> Highest priority in terms of insecurity Images 0095 to 0105 on disk
14	Cerberus	<ul style="list-style-type: none"> Satisfactory condition 	<ul style="list-style-type: none"> Images 0106 to 0107 on disk
15	The Harpies	<ul style="list-style-type: none"> Minor scrapes on back of base Small gouges on proper left side 	<ul style="list-style-type: none"> Images 0096 and 0108 to 0115

- Cyclops** has serious damage on proper left leg, a number of scrapes/abrasions, grout around base is completely cracked and the proper left elbow is cracked and loose (with potential for loss).
