## **Investigation of Spare Duct Banks to be Used for Cable Circuit Replacement Feeders A32T-A33T**

Final Draft Report

January 17, 2020

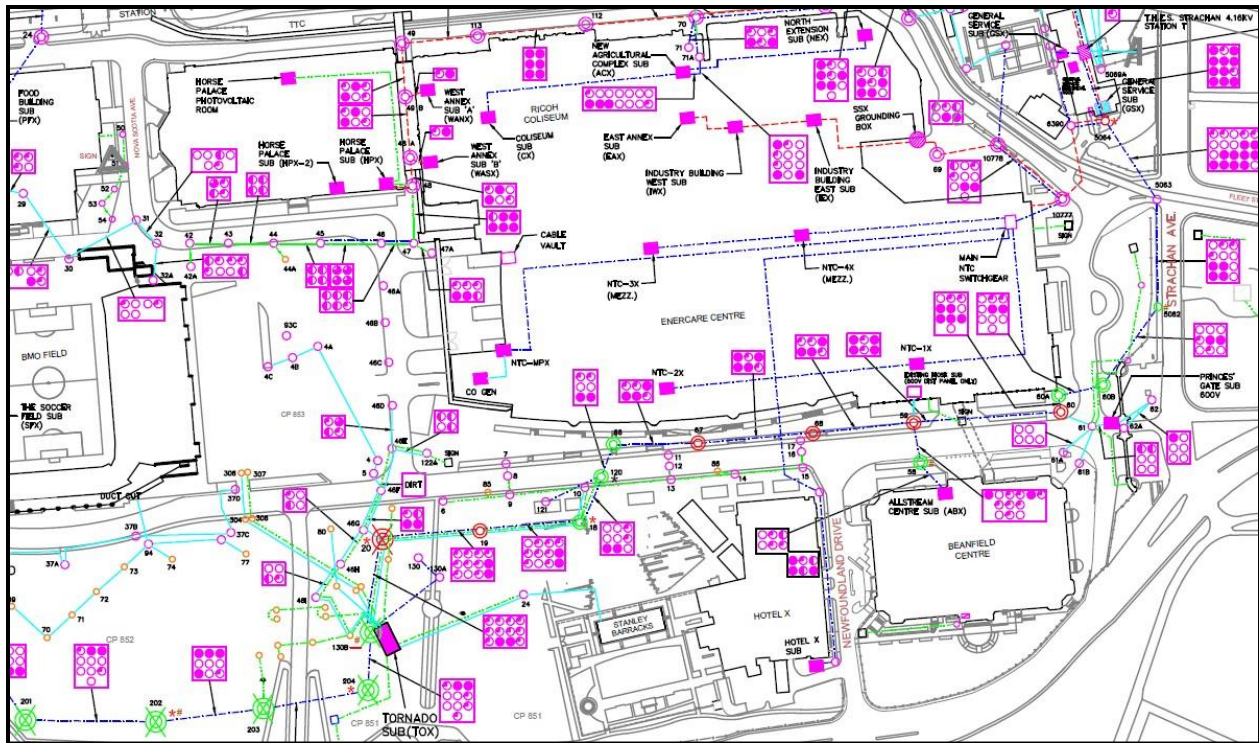
## Detailed overview of the condition of manholes investigated:

South to Manhole #5063	Yes		* Splice anomaly
5063	Not investigated			
5062	North to Manhole #5063	Yes

# Dirt and corrosion

* Oily residue
18	West to Manhole #19	Yes

* Splice anomaly
19	West to Manhole #20	Yes (1 duct)

* Splice anomaly
130B	South to Manhole #204	Yes

# Excessive grime
204	West to Manhole #203	Yes

* Splice anomaly
203	West to Manhole #202	Yes

* Splice anomaly # Dirt
201	North to Vault TWX	Yes

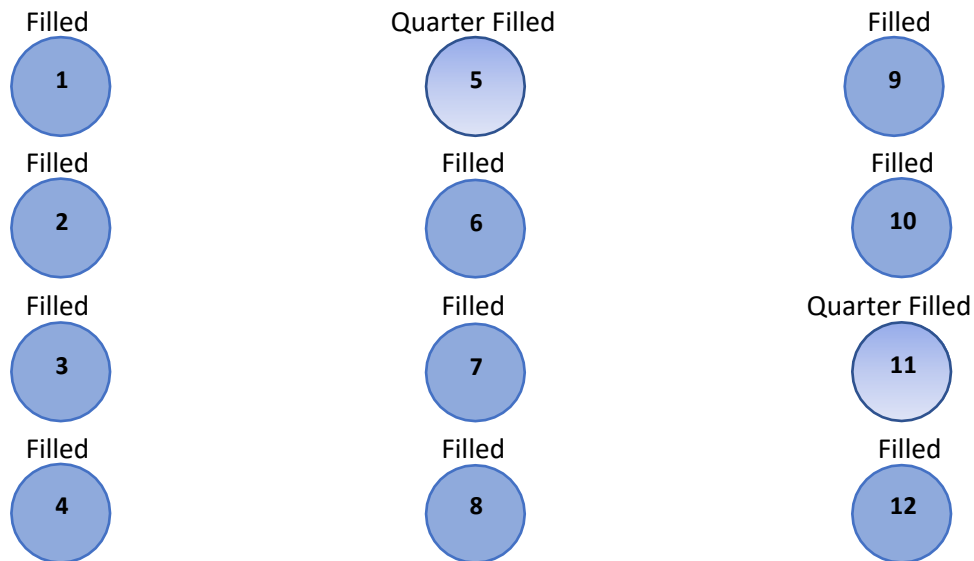
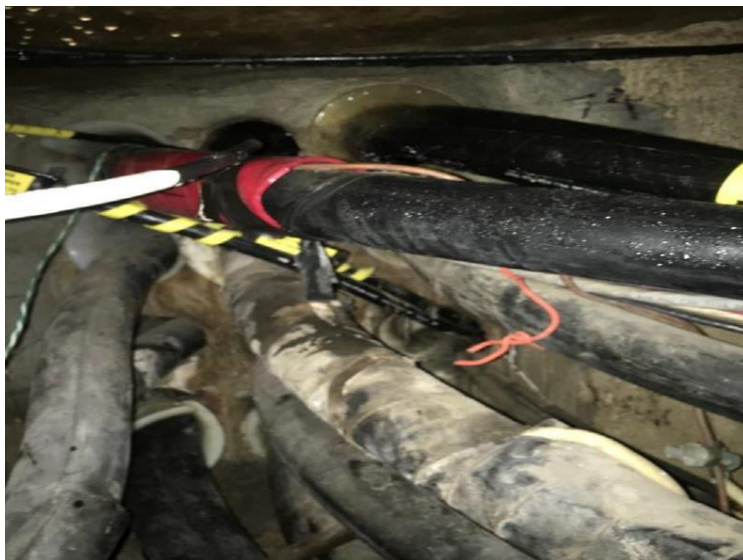
### **Manhole #1 (on our list)**

- Approximately 4" gap between 3x4 duct banks going South to Manhole #2 (5063). Need to enter Manhole #2 (5063) to know how many ducts make it there
- Unable to send the endoscopic camera through to Manhole #2 due to deformed splice found
- Duct #4 has a 13.8 kV cut off cable that can be used as a spare in the ducts going South to Manhole#2
- The manhole contains 13.8 kV and 4.16 kV cables

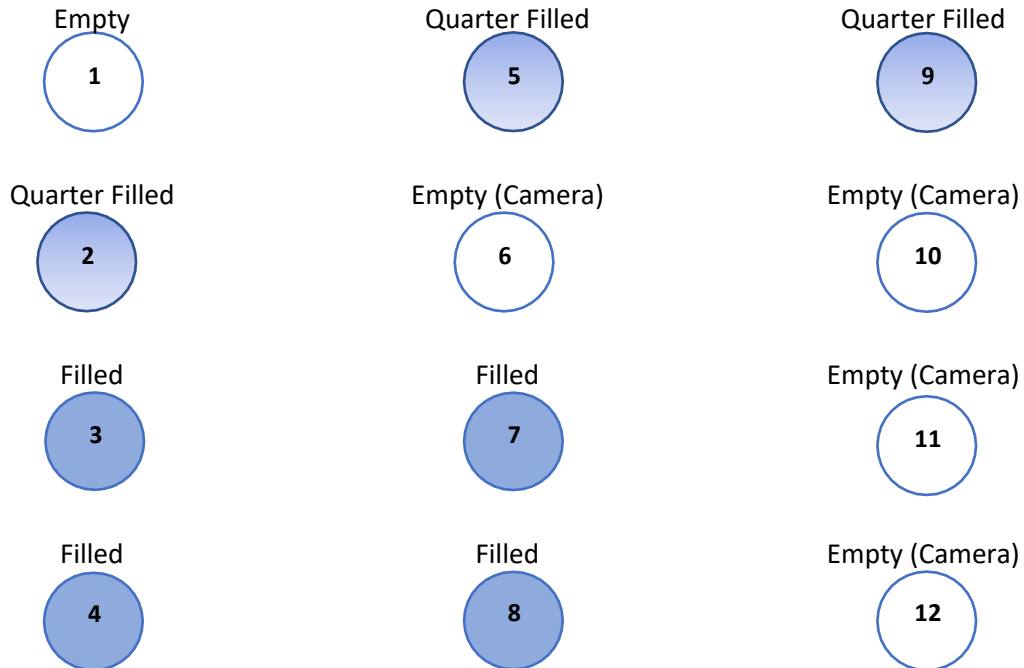
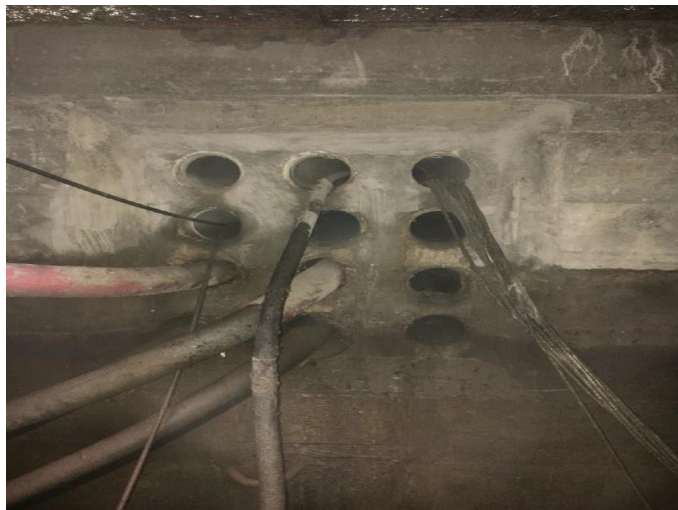
**Manhole #3 (on our list)**

- Contains a lead splice and a Raychem splice
- Endoscopic camera sent North to Manhole #2 in ducts 2, 3, 4, and 6. Excessive dirt and corrosion prevented the camera from reaching beyond ~150'. Ducts looked good otherwise and appear to just need cleaning
- Endoscopic camera and mandrel sent South to Manhole #4 in ducts 1 and 4. Ropes left in ducts.

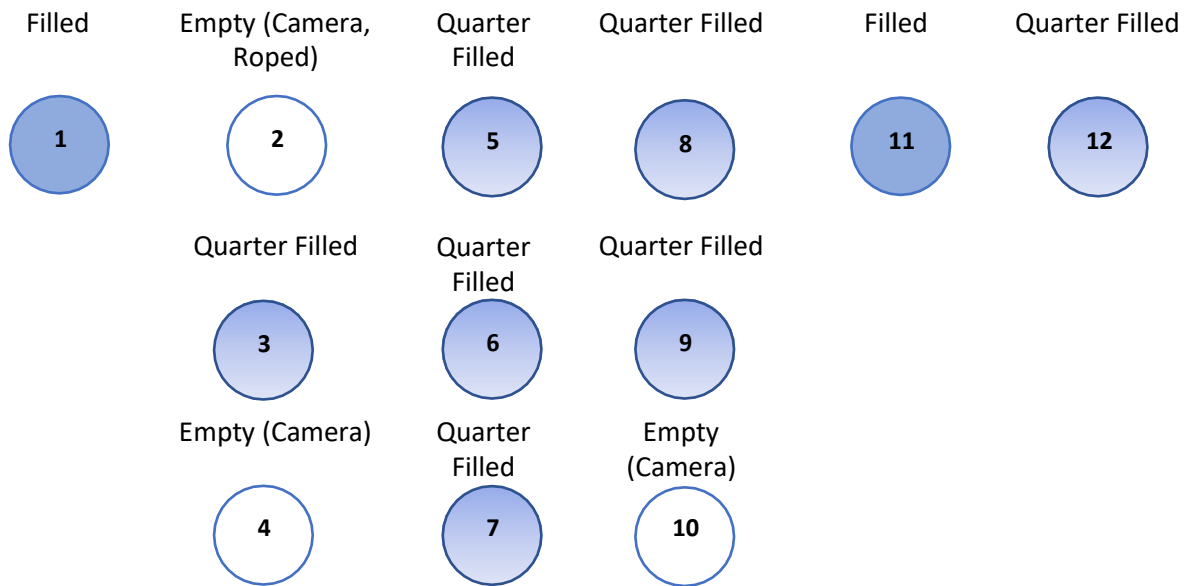
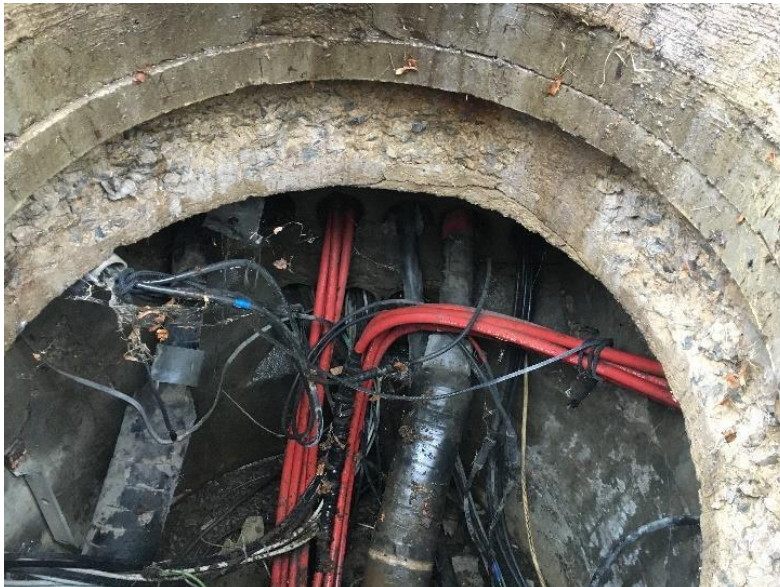
**Manhole #8 (on our list)**

- Distance to ground ~10'
- Endoscopic camera and ribbon sent North to Manhole #7 in duct 2. Could not get mandrel through more than 5' of the duct. Could not observe any anomalies with the camera. Ribbon left in the duct.
- Endoscopic camera sent North to Manhole #7 in ducts 4 and 10. Excessive dirt and corrosion prevented the camera from reaching beyond approximately 22 and 27 meters respectively.
- This manhole contains an abundance of low voltage and communication cables going South, likely into the building. (Out of scope)

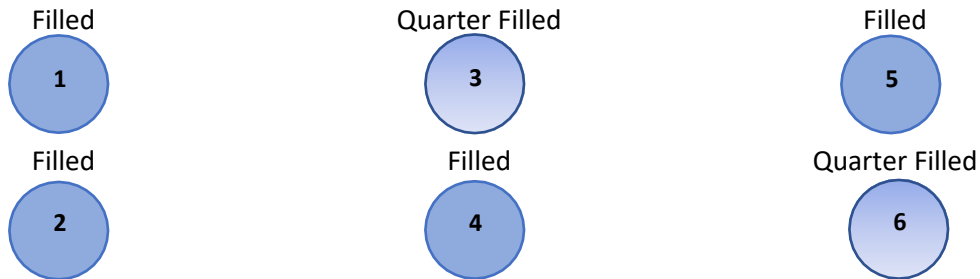
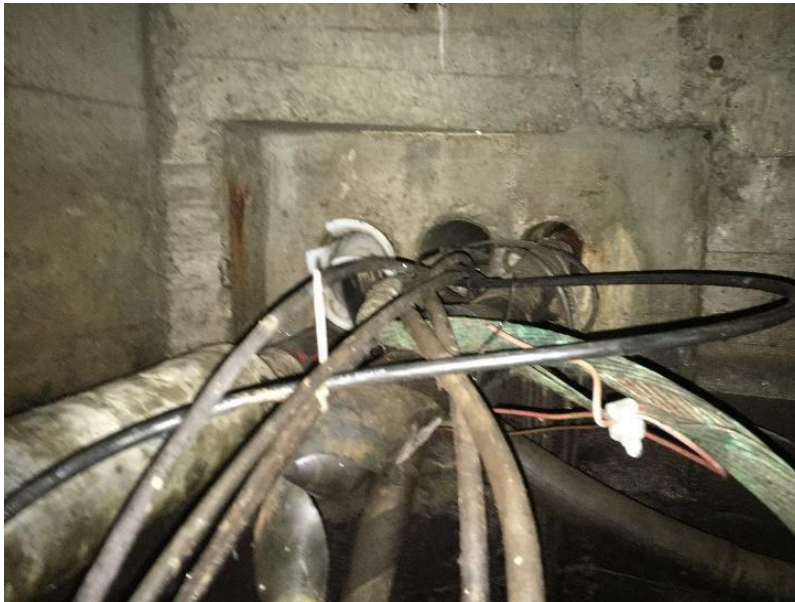
**Manhole #9 (on our list)**

- Distance to ground ~16' (Contains ~6' "chimney")
- No ducts available heading to Manhole #10, however, duct 4 contains an old 13.8 kV PILC cable that has been cut
- Duct 5 contains a 13.8 kV PILC cable that has been cut in Manhole #10

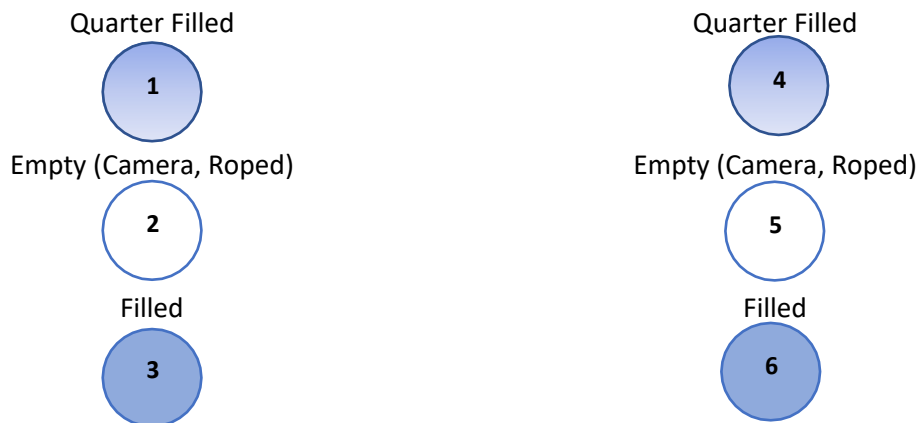
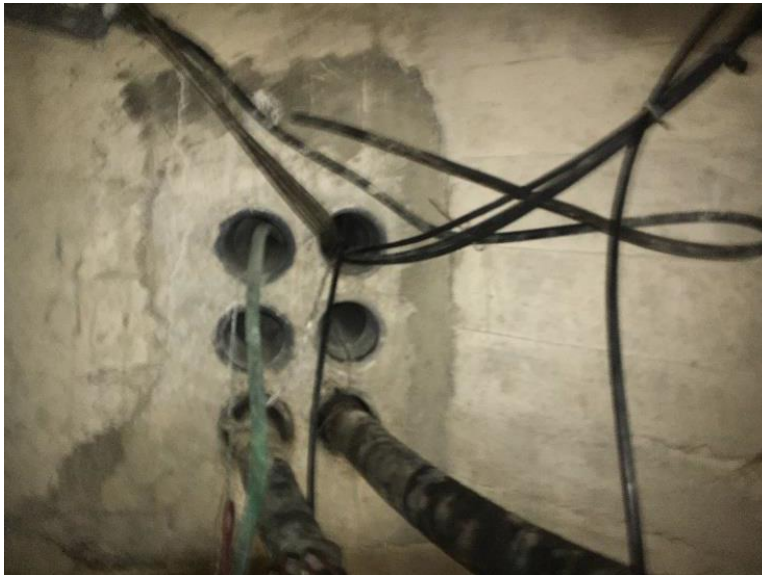
- Distance to ground ~16' (Contains ~6' "chimney")
- Endoscopic camera and Mandrel sent South to Manhole #12 in ducts 2 and 5
- Mandrel went through duct 2 but got stuck in duct 5, about 10' South of Manhole #11. We had no choice but to abandon it

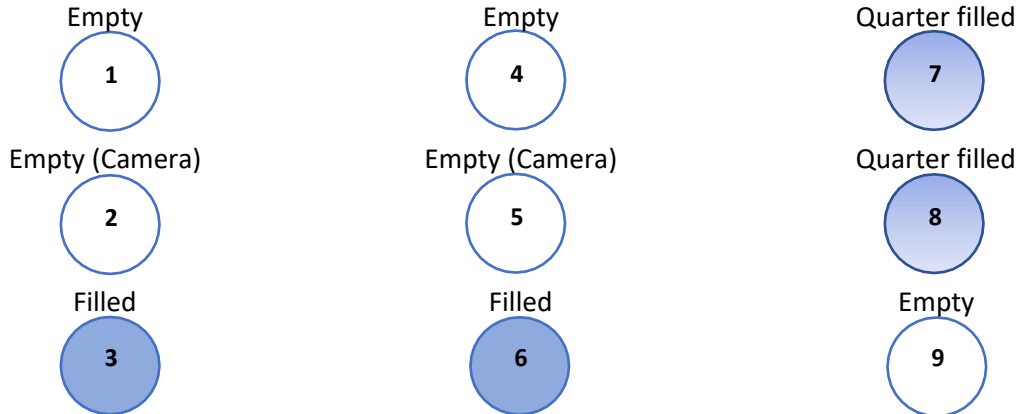
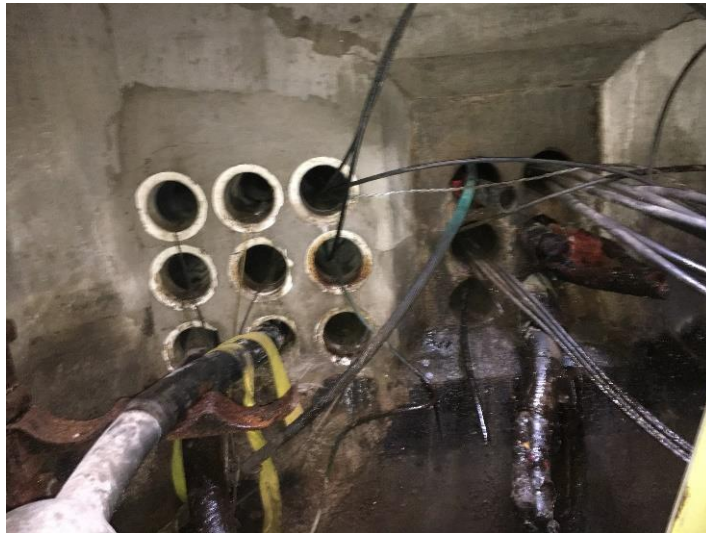
- Distance to ground approximately 13' (Contains ~3' "chimney")
- Had to grind tacks off of manhole lid prior to opening. This will need to be rewelded in the future as required
- Some cut off 13.8 kV PILC cables contain oily residue as do some splices on other cables
- Endoscopic camera sent South to Manhole #13 through ducts 2 and 5. No anomalies noted

- Due to a deformed splice found in Manhole #13, we could not send the mandrel through either duct

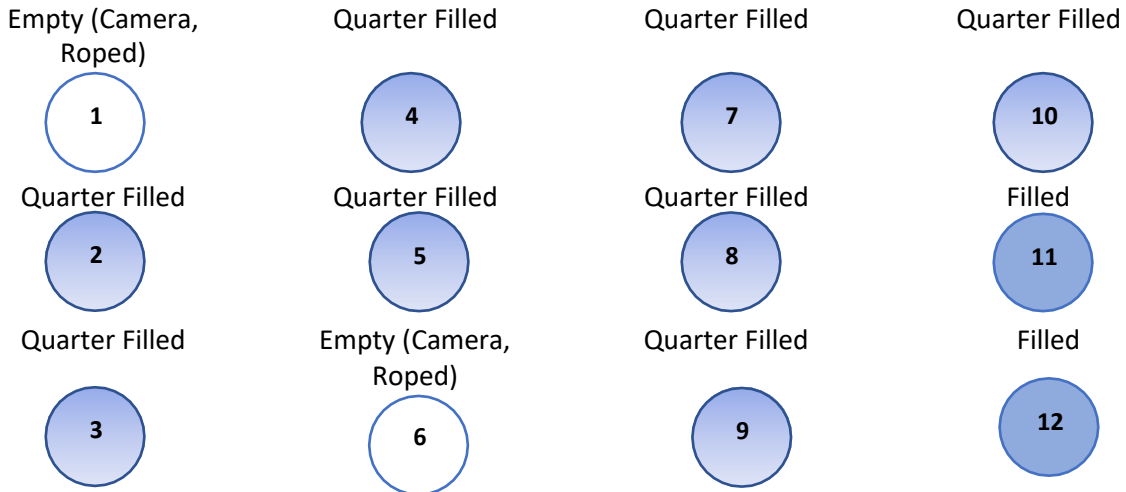
- Distance to ground approximately 14' (Contains ~4' "chimney")
- Found a deformed 13.8 kV PILC splice just off of the floor

- Endoscopic camera sent through ducts 1 and 6. It could not reach the entire stretch but it went through very easily with no noted anomalies. Ducts both found roped.
- Entry into the manhole was very difficult due to an abundance of LV cables coiled around the chimney

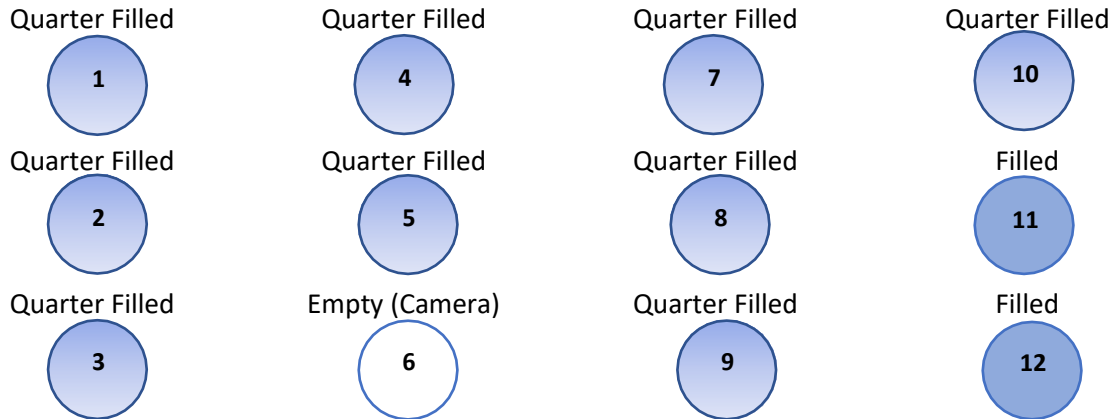
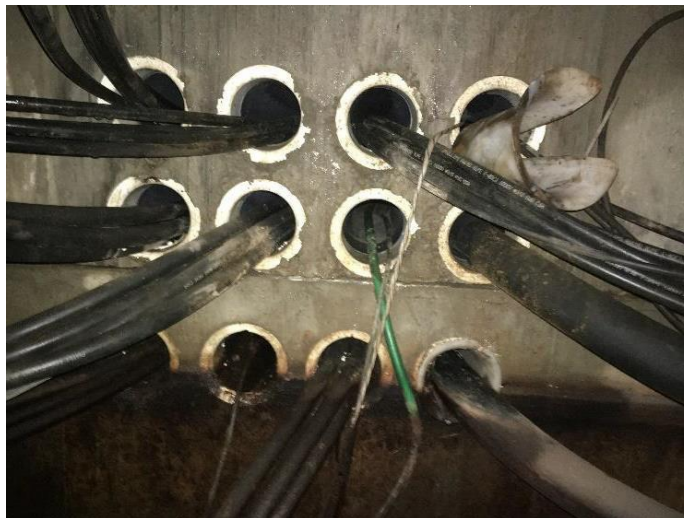
- Distance to ground ~15'
- Endoscopic camera sent most of the way through duct 6. Looked satisfactory but hit water about two-thirds of the way through. Could not make it all the way.
- Cut off communication cable has been left in duct 6 as found.
- Mandrel not sent due to compressed splice anomaly found in Manhole #15

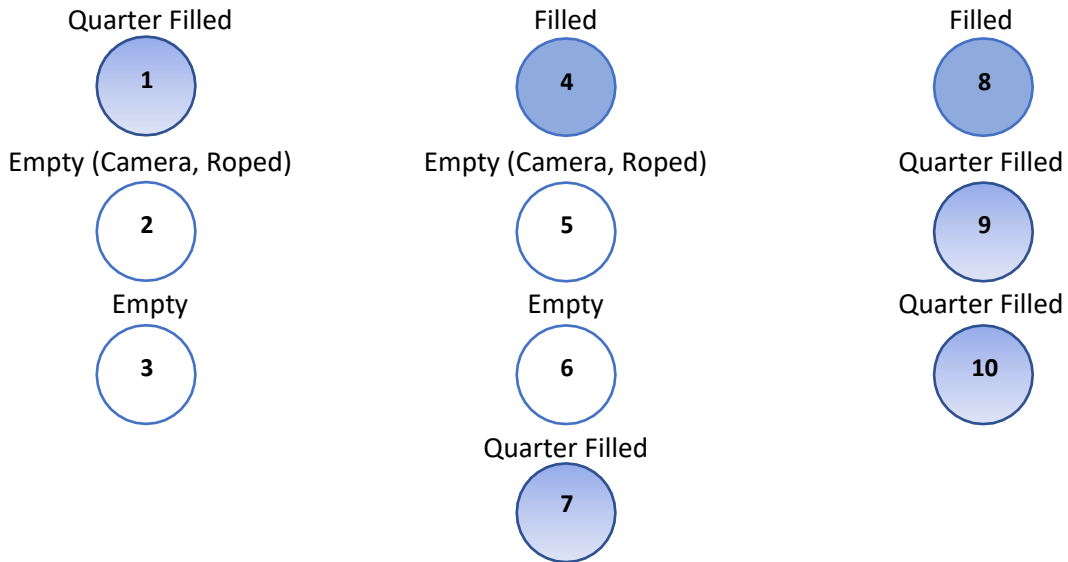
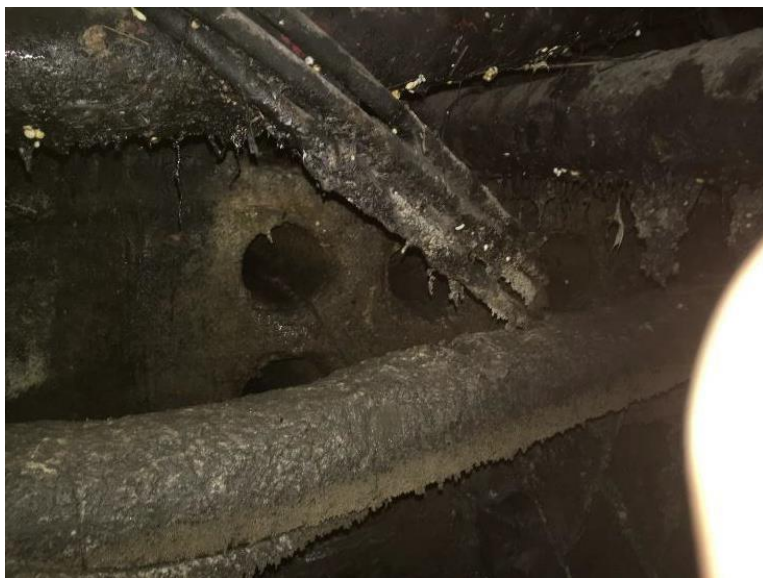
- This Manhole appears to be utilized as a hub of sorts being located right at Vault TOX. There are many other ducts going multiple directions that were out of our scope
- The most confusing aspect was that the duct bank running north towards Manhole #15 had the 13.8 kV feeds in the bottom middle two ducts and the accompanying ground in the bottom east duct as expected. However, all the other ducts were empty. No way of knowing where they are going/coming from
- Sent the camera through two ducts (2 and 5) but could not make it through the whole stretch due to excessive grime. Pulled on the twine at each end to confirm continuity. Ducts will need to be blasted clean
- This manhole is particularly filthy compared to the others

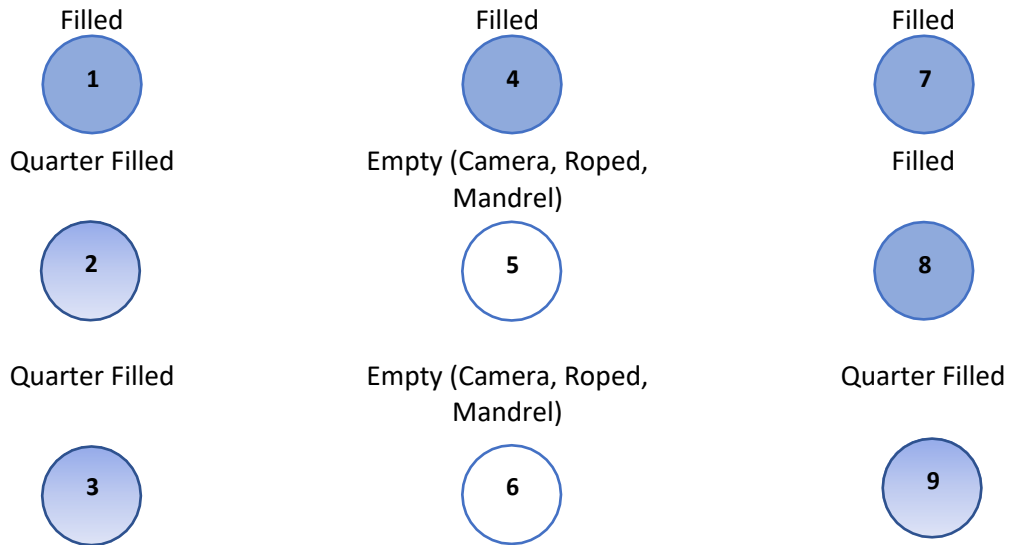
- Distance to ground approximately 12'
- Compressed splice found on 13.8 kV cable in duct 8. It didn't look as bad as some of the others so the technician was comfortable working near it for a short time
- Endoscopic camera and mandrel sent West to Manhole #18 in ducts 5 and 6
- Rope left in ducts after sending through the mandrel

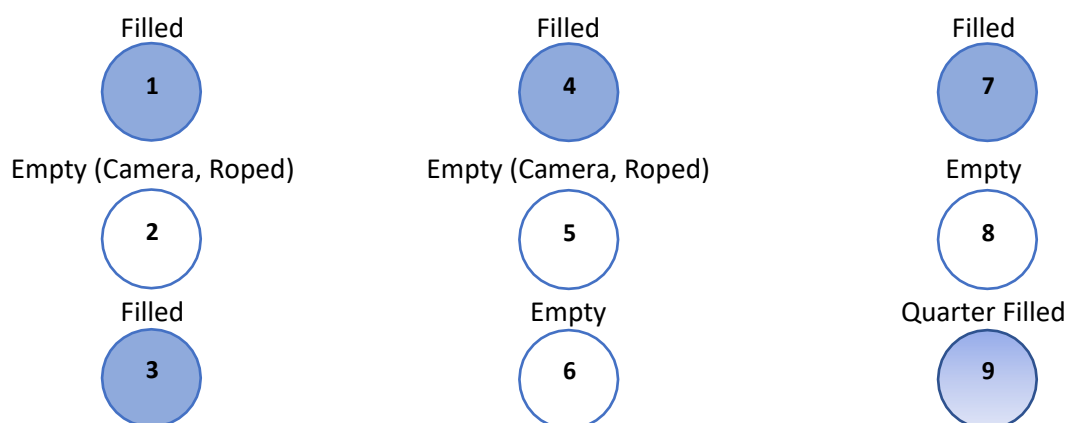
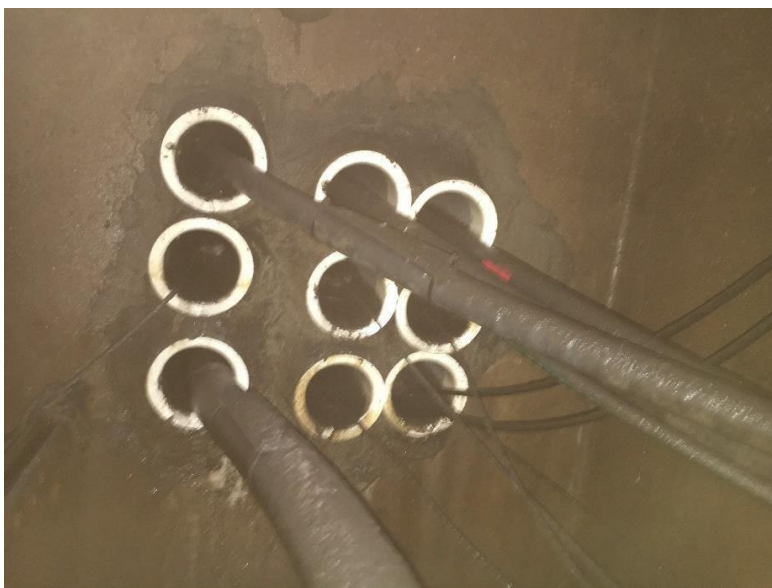
- Distance to ground ~15'
- Sent the endoscopic camera through ducts 2 and 5 (from inside 18), but were unable to make it all the way. The stretch that we did look good and was clear aside from some water build-up
- Found existing twine in all empty ducts
- We could not send the mandrel through due to the splice anomaly found in manhole #19

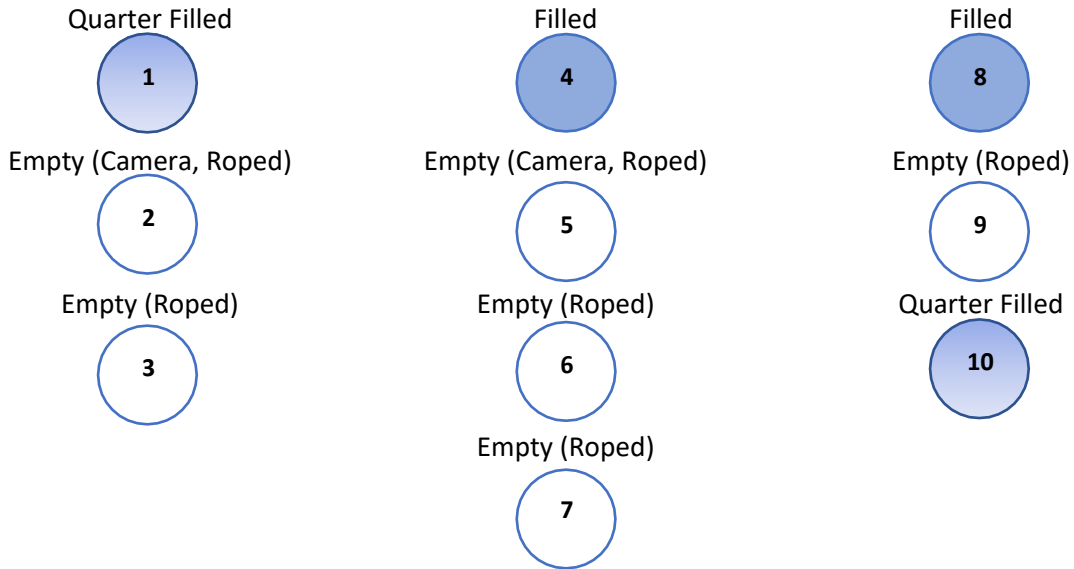
- Distance to ground ~15'
- We found another splice anomaly. It had a compressed area on it as well as some bulges
- We sent the endoscopic camera through ducts 2 and 5. The camera couldn't reach the whole stretch and we found it to have a lot of dirt/contamination built up as we approached the end. Ducts will have to be blasted clean but looked good overall
- We were unable to send the mandrel through due to the splice anomaly in Manhole #19
